**Escapement Numeration of *Oncorhynchus kisutch* in Chester Creek
Anchorage, Alaska**

Brandon R. Forsythe

Alaska Pacific University

Department of Environmental Science

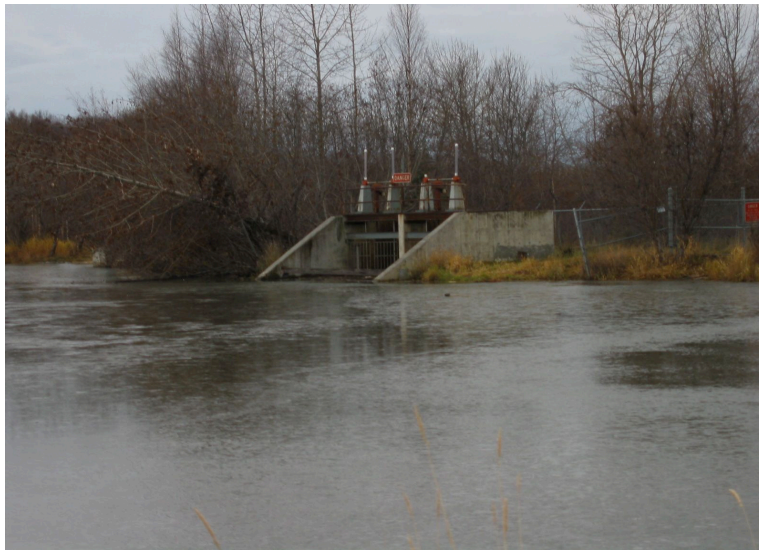
Figure 1 Westchester weir that existed 1970-2008

Salmon populations were severely impacted due to the weir restricting anadromous fish passage into Chester Creek (Davis & Muhlberg, 2001). The design of the weir forced salmon to travel through two culverts 24 meters long. In order for the salmon to enter these culverts, the tide levels need to be within -1.25 to 1.19 meters of mean sea level (MSL) since fish avoid diving near stream entrances (USACE 2004)

and have limited ability to leap into the culverts. These culverts are routed underground with a height difference of 12.50 m between the Knik Arm and the weir. Water leaving the lagoon falls approximately 3.66 meters and enters the culverts and is routed to the inlet. Coho's known maximum vertical leap is 2 meters (Sandercock 1991). This further limited successful escapement of coho and took away the mixing zone that would allow juvenile salmon returning to Cook Inlet to acclimate to saltwater. It was found that in order for the coho to successfully leap into the lagoon the incoming high tide had to reach approximately 8.53 meters.

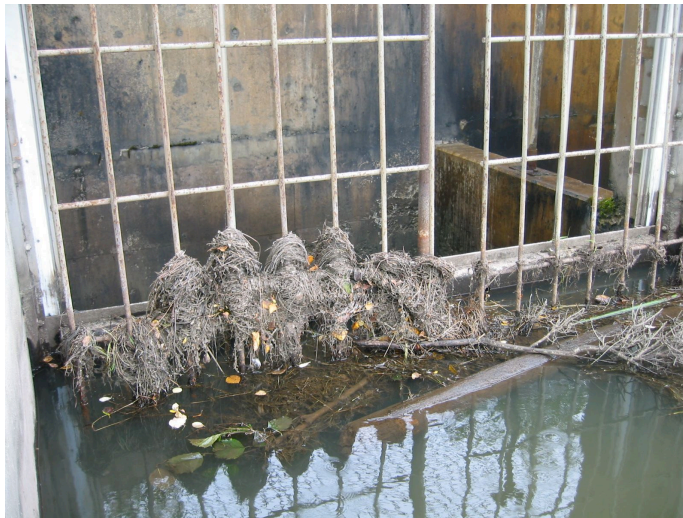
Entrance into the weir from Westchester Lagoon was also hindered due to a front grating that was installed and blocked debris from falling into the culverts (Figure 2). The bars on the grating were spaced 15 to 20 cm apart. The debris consisted of a thick mat of vegetation growing at the water line

Figure 2 Grating showing debris.

and woody material from upstream. The size of the woody debris ranged from small sticks to logs 5.12 meters in length and 15- 20 cm in diameter. The buildup of debris over time also hindered successful escapement of coho. The stream corridor has been impacted by urbanization reducing water quality, stream channel alterations, erosion, and poor riparian zones. Healthy riparian zones are important to shade the stream and maintain water temperatures sufficient for salmon habitat (Madej, 2006). Riparian zones also provide allochthonous production required for salmon diets (Hetrick et al. 1998).

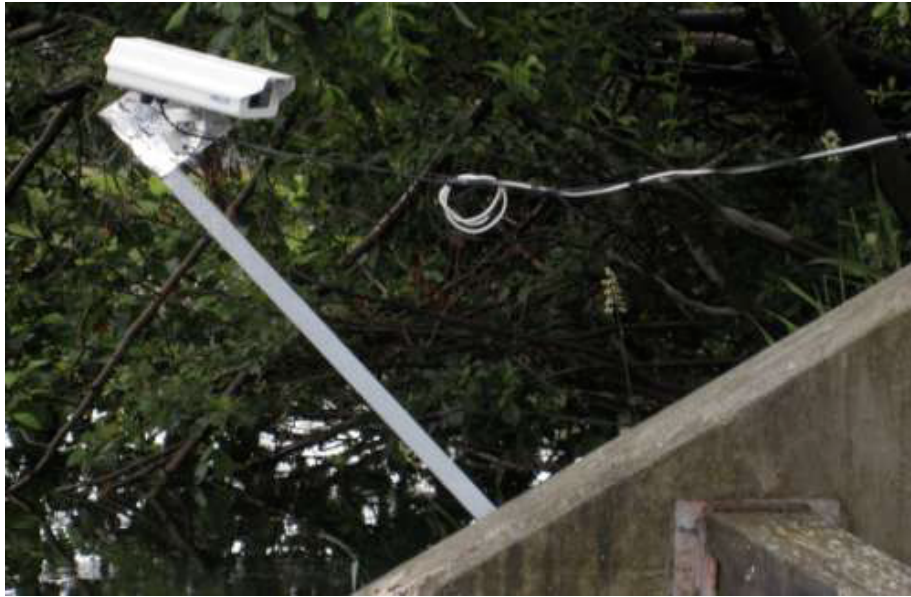
One camera was placed on the side of the west wing wall using a metal pipe rock bolted to the wall (Figure 3). The camera faced in a downstream direction focusing on the left portion of the weir 3.4 meters away from the weir waterfall ledge. The second camera was installed on the top center of the weir pointing downward focusing on the right side of the weir 3 meters above the ledge. It was attached using u-bolts to grating placed on top. Both sets of lights were placed on top of the weir pointed downward towards the water at angle to reduce glare.

Figure 3 Camera attached to weir.

Two cameras (Toshiba Digital Color Camera; model IK-64WDA) were installed with a 5-40 optical power range. Cameras were placed in a weatherproof case manufactured by Pelco, Clovis, CA (model # EH3512). Tiffin circular polarizers mounted on the lenses reduced glare. Images were recorded on a Sanyo Digital Video Recorder (model # DSR-3506). Two sets of halogen lights were used during dark hours providing sufficient lighting requirements. Power supply for the video recording system and lighting was provided by a Honda generator (model EU2000i). The generator AC output was 120 volts, 2000 watts, and 16.7 amps. The digital recorder and generator were housed in an old weather station box. A tub was placed under the generator in the event of an oil or gas spill.
